## TEST REPORT

Report No. : TH60147/2020

Product Description: Magical Socket

Test Requested: Torque Capability

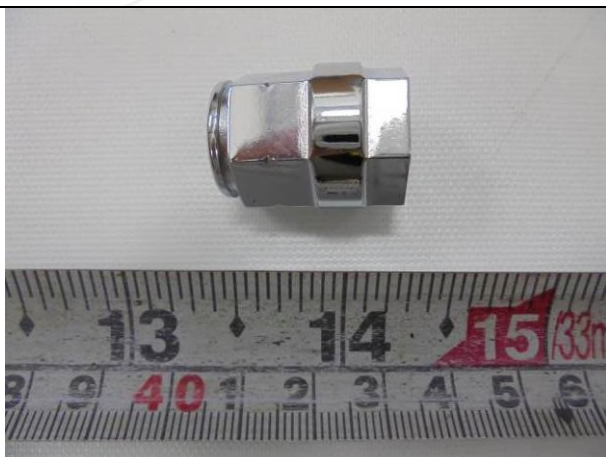
Photo "A" Appearance of sample (3/8 "Dr)

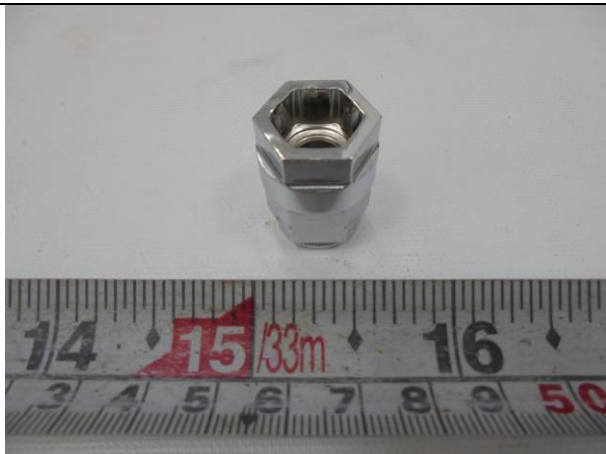
Photo "B" Appearance of sample (3/8 "Dr)
