## TEST REPORT

Report No. : TH60154/2017

**Product Description:** 17H (3/8" Dr.) & 22H (1/2" Dr.) Insert-Snap Wrench

**Test Requested:** Torque Capability Test

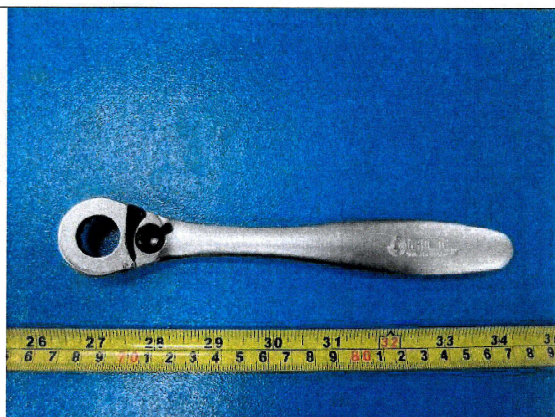
Photo "A" Appearance of sample  
-17H (3/8" Dr.) Insert-Snap Wrench

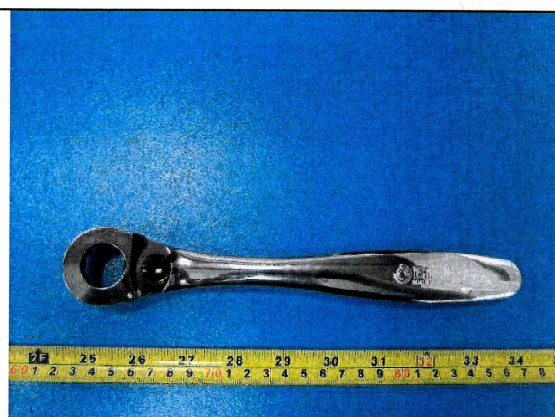
Photo "B" Appearance of sample  
-22H (1/2" Dr.) Insert-Snap Wrench
